**Flood Control Project Maintenance
Levee Inspections****LMA District Cover Sheet****Spring 2013 Levee Inspection Results****Sacramento Maintenance Yard East Levee Yolo Bypass**

Levee Inspection Report By Mile - Spring 2013

Waterway					Bank	Unit Miles	Inspection Start/End	Inspector
Unit No. 01 Yolo Bypass					Left	2.00		John Williamson

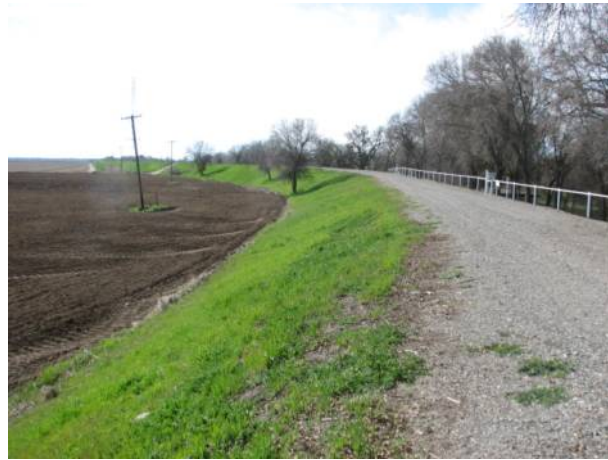
johngw_s_20130325_830.JPG

Levee Mile Report Line	4
Start Levee Mile	0.01
End Levee Mile	2.00
Location	Land Side
Category	
Item	Vegetation

The levee has no unwanted vegetation. Spring 2013

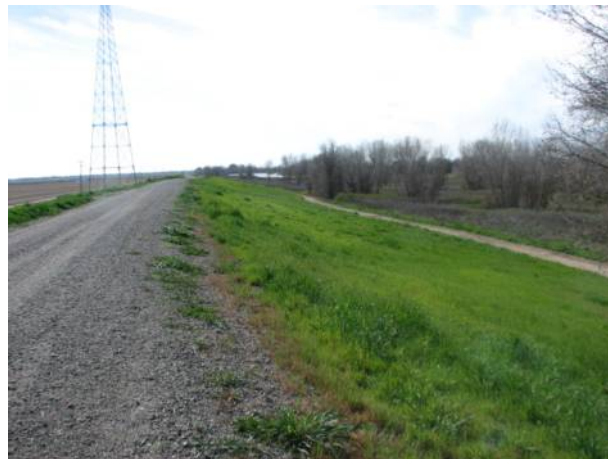
johngw_s_20130325_831.JPG

Levee Mile Report Line	5
Start Levee Mile	0.18
End Levee Mile	2.00
Location	Water Side
Category	
Item	Vegetation

The levee has no unwanted vegetation. Spring 2013

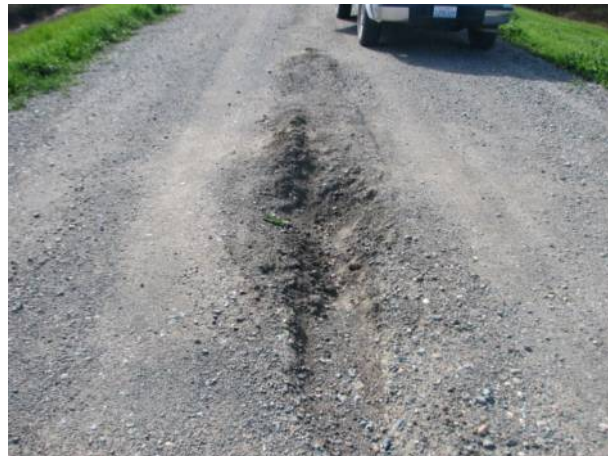
johngw_s_20130325_832.JPG

Levee Mile Report Line	6
Start Levee Mile	1.54
End Levee Mile	1.54
Location	Crown
Category	
Item	Crown Surface / Depressions / Rutting

A rut not greater than 6" in depth on the levee crown. Spring 2013

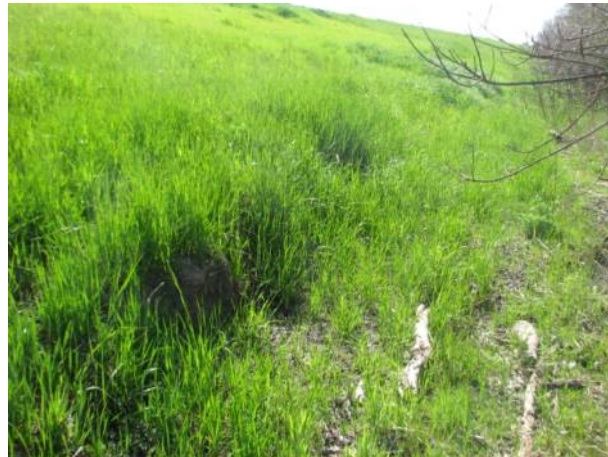
johngw_s_20130325_833.JPG

Levee Mile Report Line	7
Start Levee Mile	1.79
End Levee Mile	1.85
Location	Water Side
Category	
Item	Erosion / Bank Caving

Erosion at the toe of the waterside levee slope. Spring 2013

DWR ID: DWR_ST0004_01_s_2013_2										
7	1.79	1.85		Erosion / Bank Caving	WS	M Ma	E1 : Note and monitor erosion site.	38.739177 ° -121.633892 °	38.738305 ° -121.633815 °	19 Y
DWR ID: DWR_ST0004_01_s_2012_19
